## Dilapidation Inspection Report

Type of Report: Dilapidation Inspection

Dilapidation Inspection Report

Type:	Domestic	Semi Detached
Bedrooms:	4	
Bathrooms:	2	
Ensuites:	-	
Car Park:	Single	
Height:	Two Story	
Building:	Brick Veneer	
Piers:	Concrete	
Floor:	Timber with concrete areas	
Roof:	Metal	
Age:	1990s

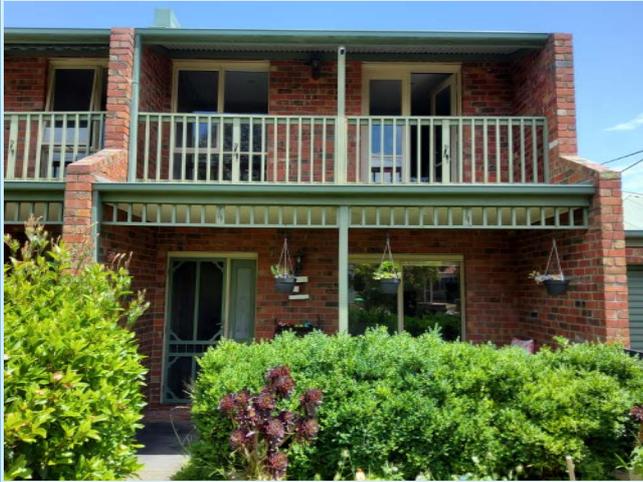
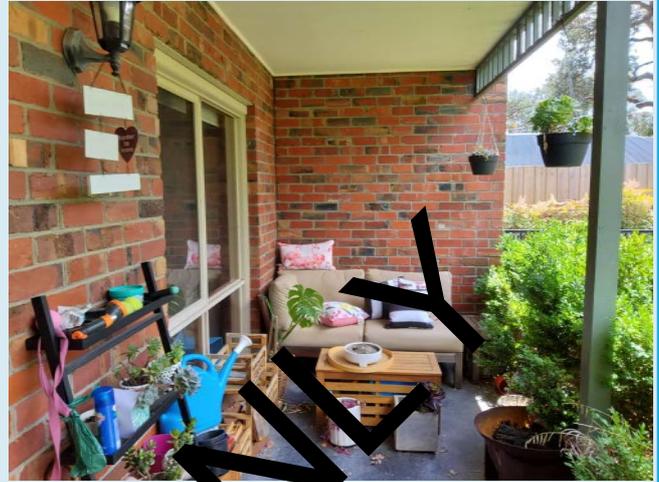
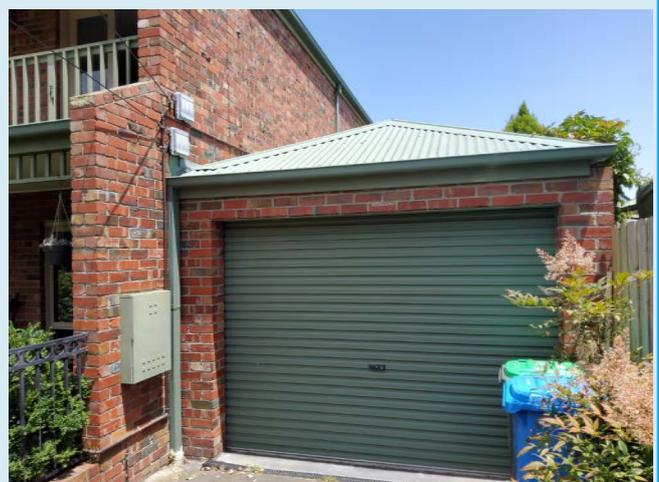
Walls

Front elevation, visually fine.

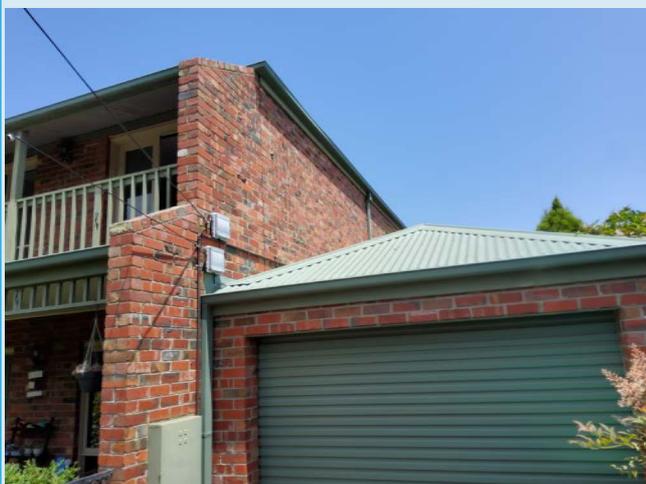
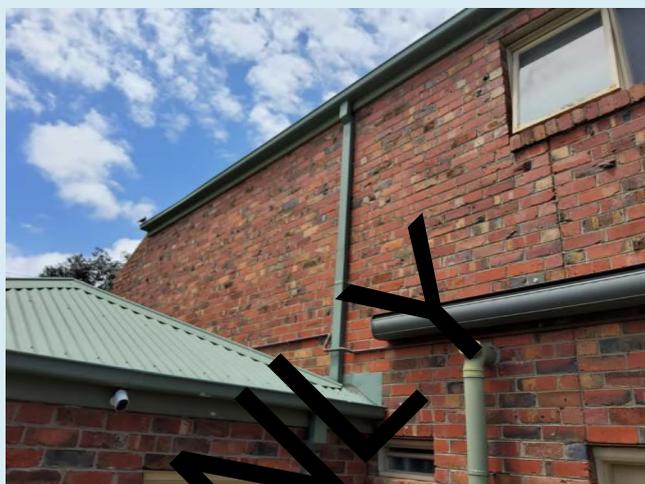
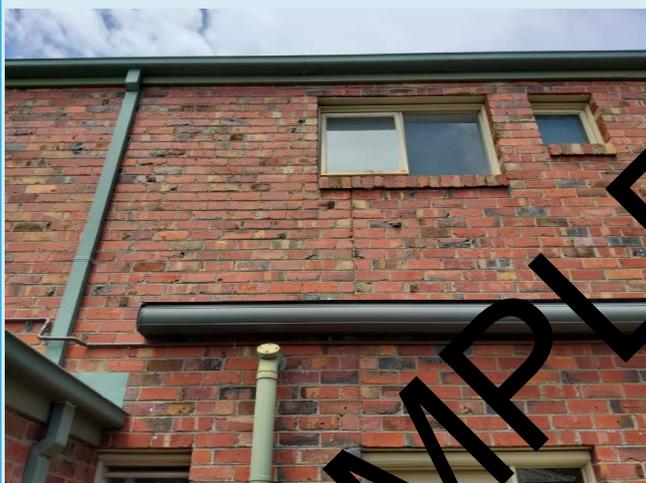
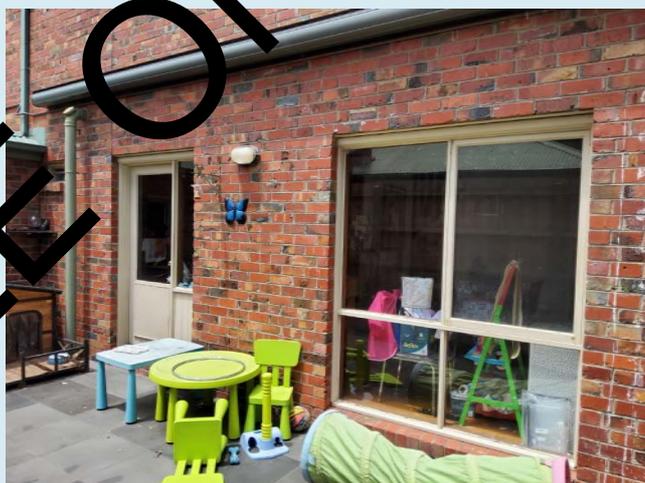
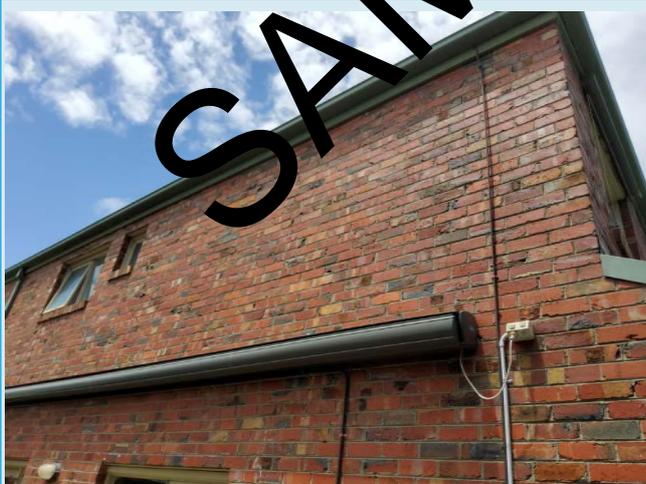
Walls

Side elevation, visually fine.

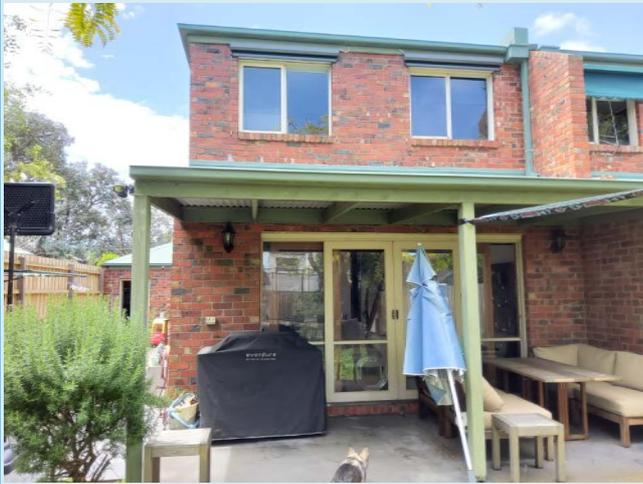
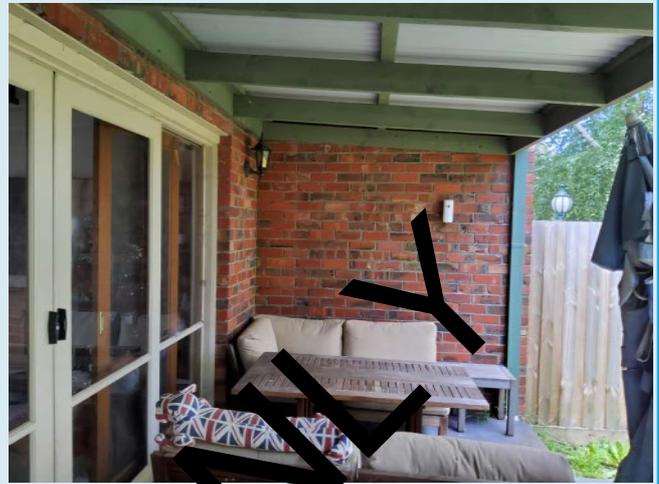
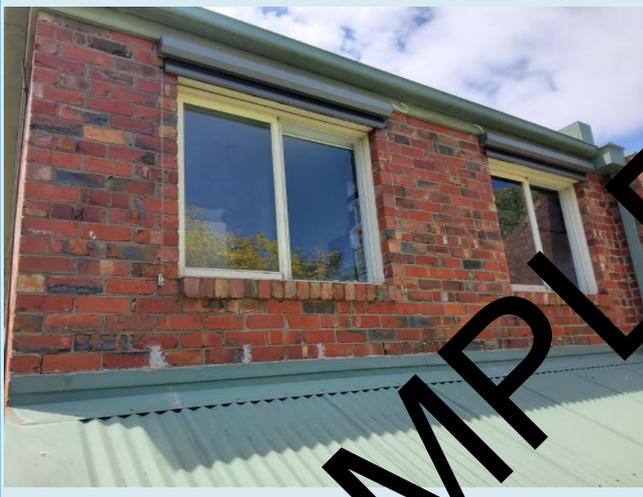
Walls

Rear elevation, visually fine.

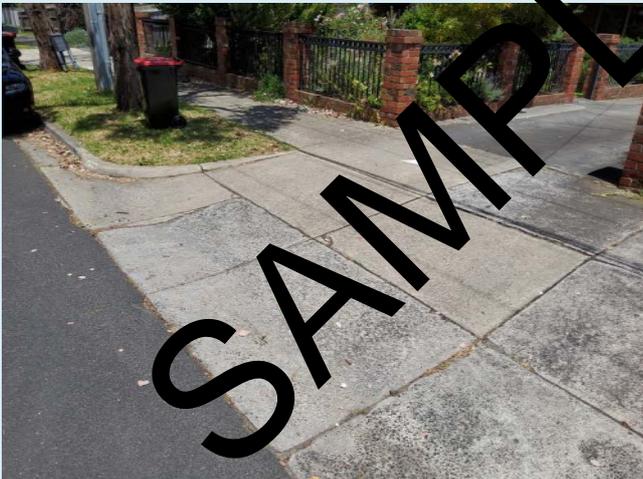
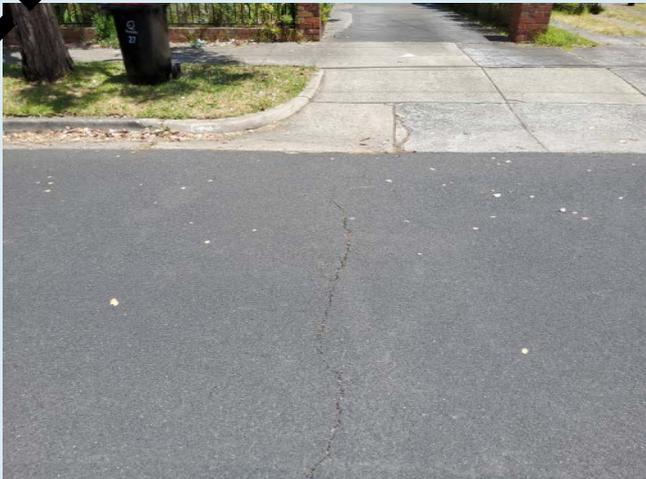
<b>External of Property</b>	
<b>Damage advice on Item</b>	<b>Driveways and paths</b>
<b>Comments</b>	
Minor cracks to driveway crossover and roadway at the front of the property.

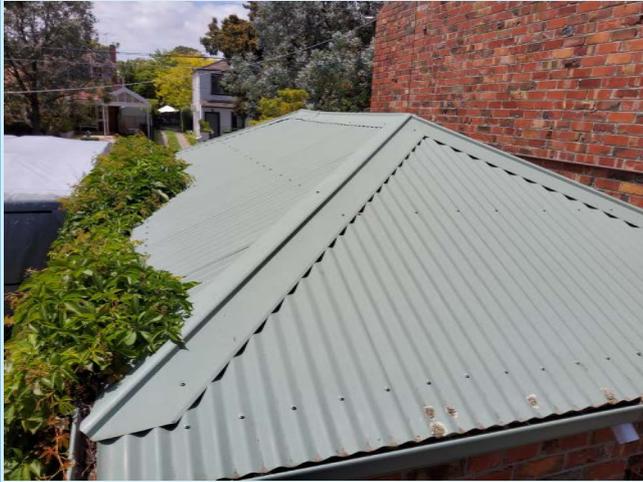
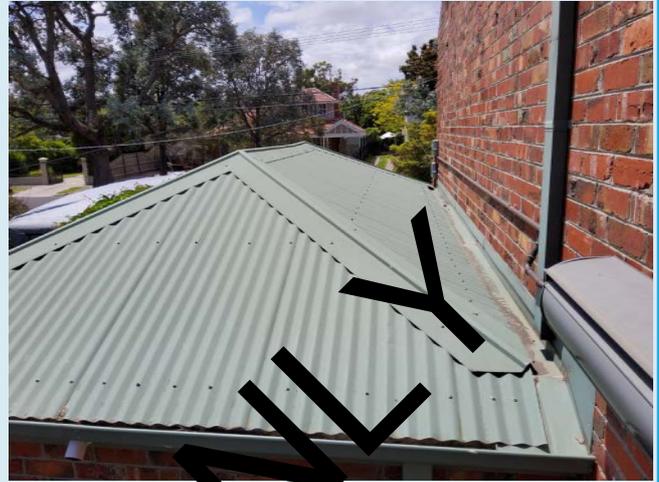
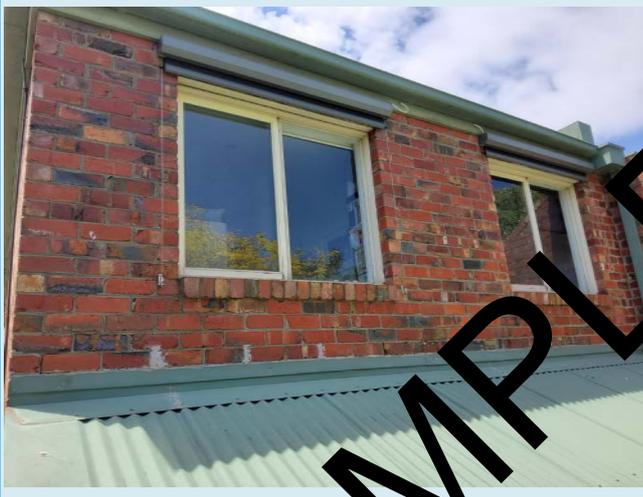
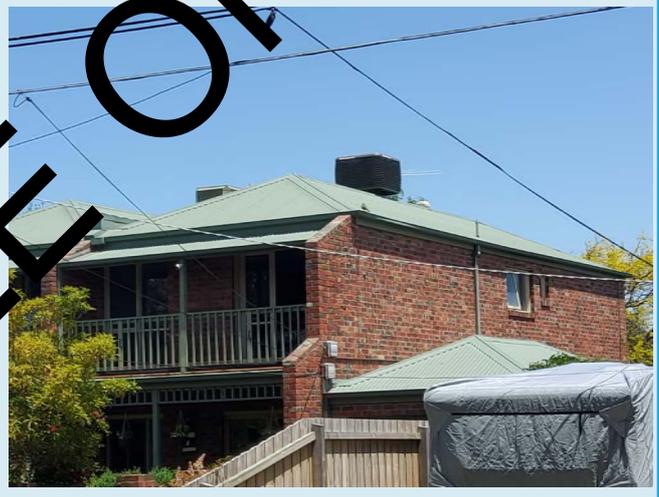
Roof

Accessible roofs appeared visually fine.

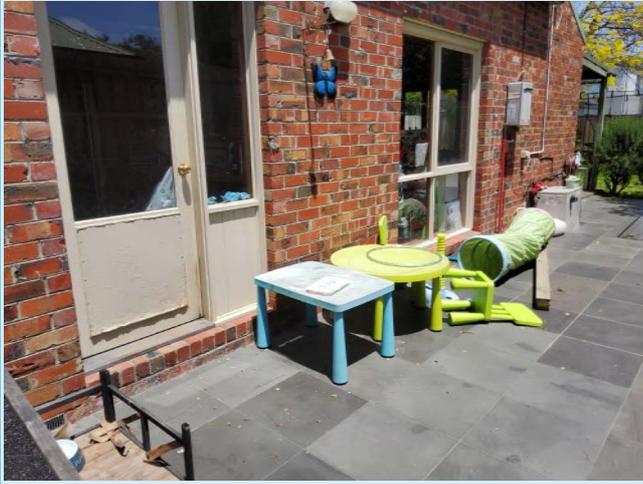
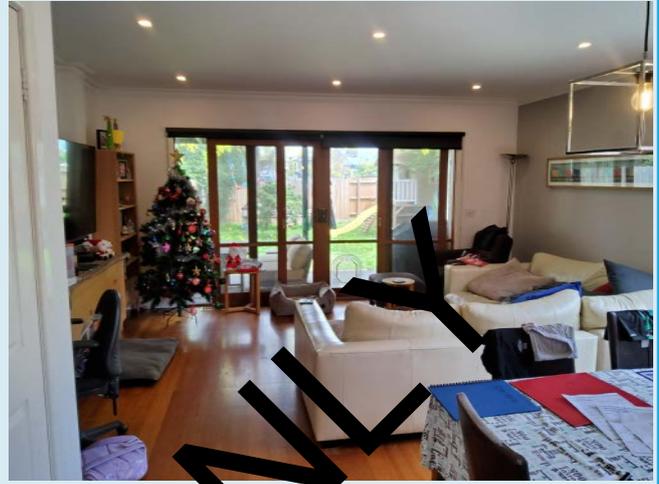
**Sub Floor Ventilation**

**No access to the subfloor area, no access traps.**

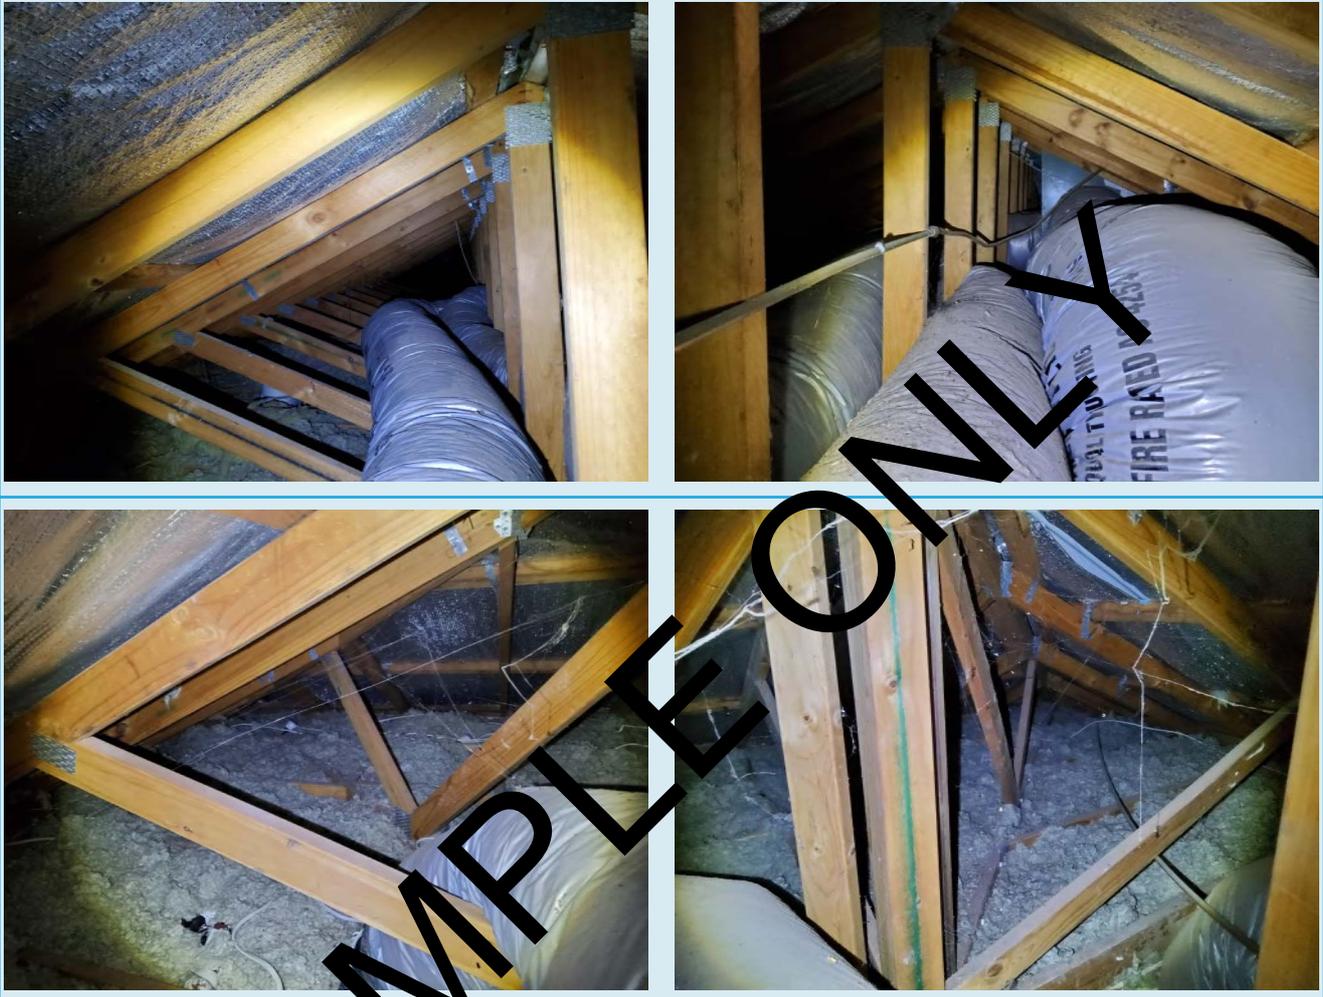
Roof Space

Roof space inspection was limited by low clearance, insulation and ducts. Timber structure appeared fine where visible at the time of inspection.

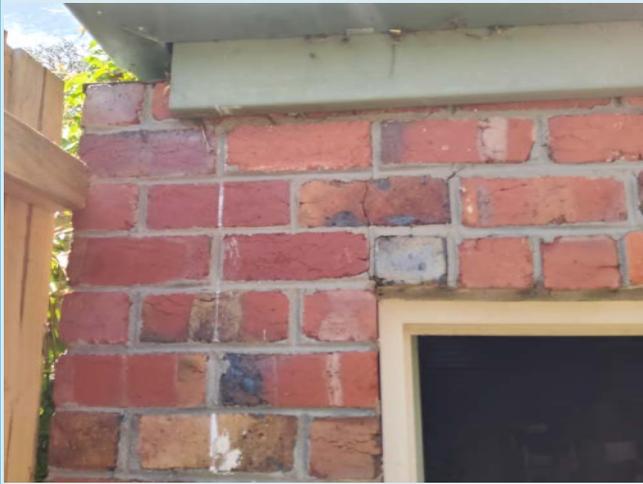
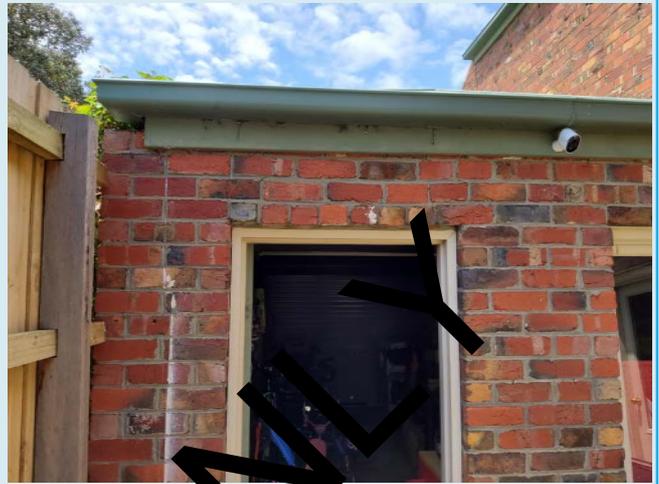
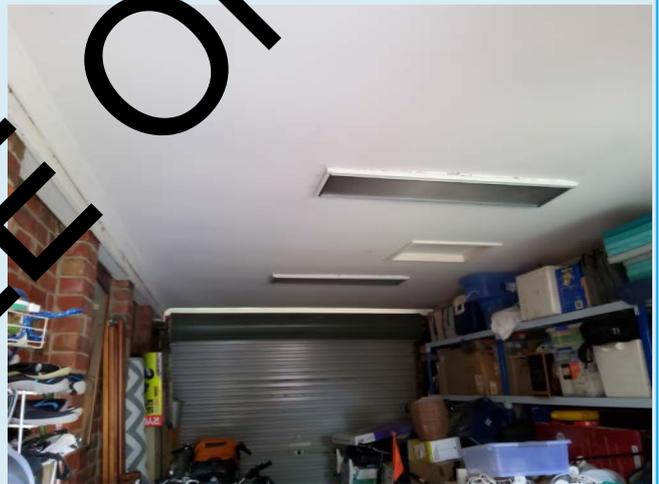
**Garage/Car Port**

**Very slight crack to brickwork at the rear of the garage. Otherwise fine where visible.**

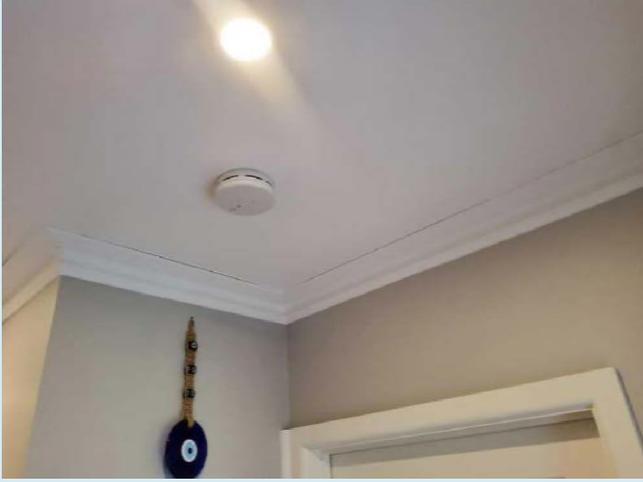
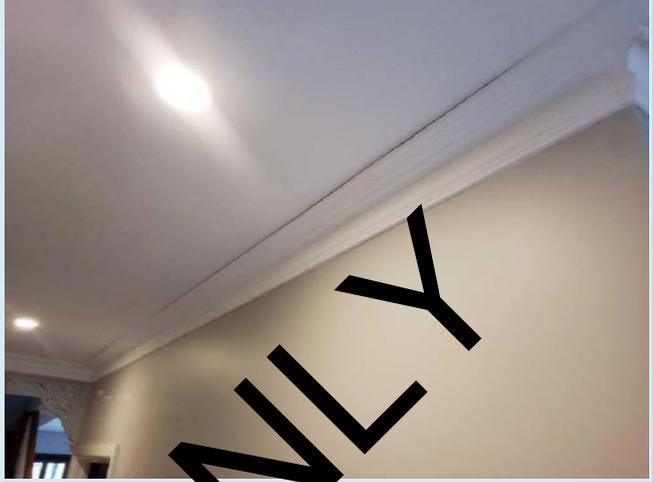
<b>Internal areas</b>	
<b>Damage advice on Item</b>	<b>Entry/Hallway</b>
<b>Comments</b>	
Slight gaps between the cornice and ceiling around the tfront entry area.

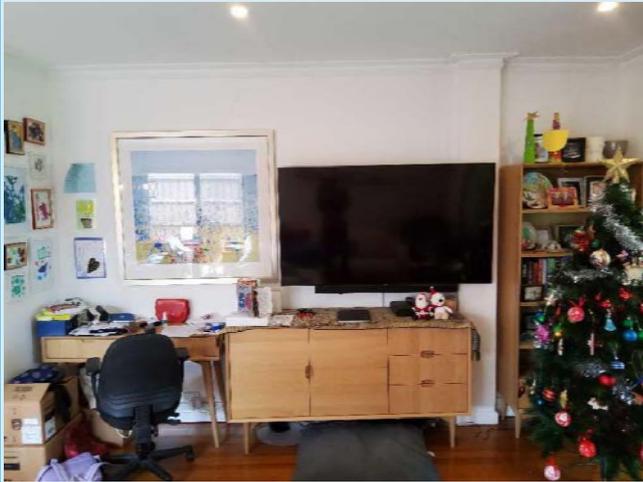
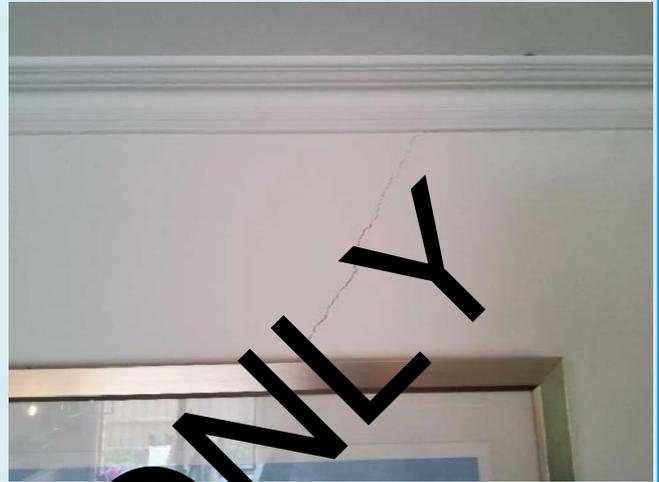
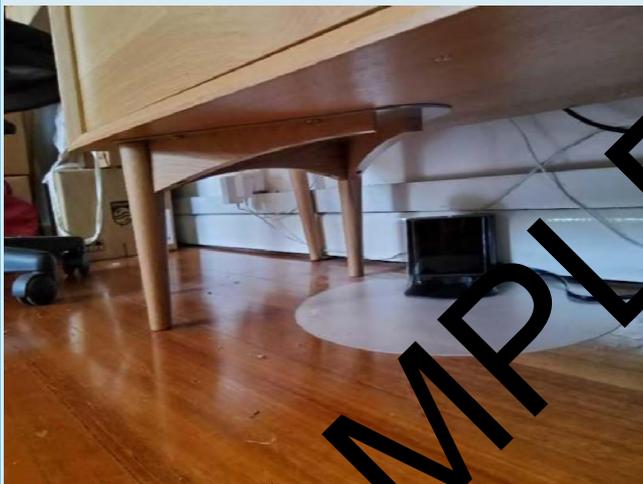
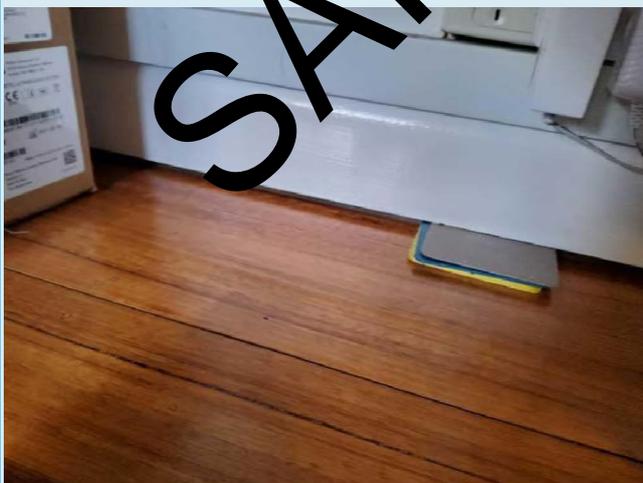
Very slight diagonal crack to plasterboard wall lining on the left side of the loungeroom.  
Up to 8mm gap between the skirting board and floor along the left side, and slightly springy floor underfoot suggests minor settlement or other damage to stumps/framing below this area.

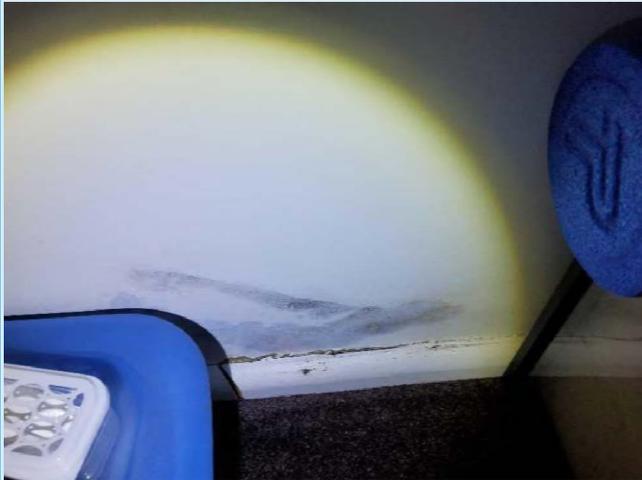
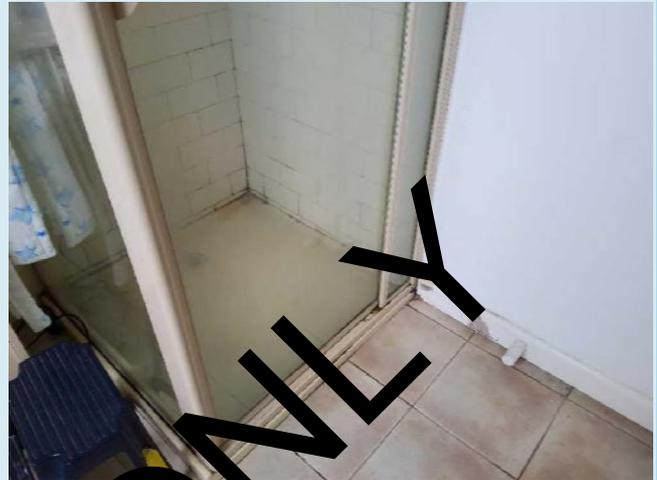
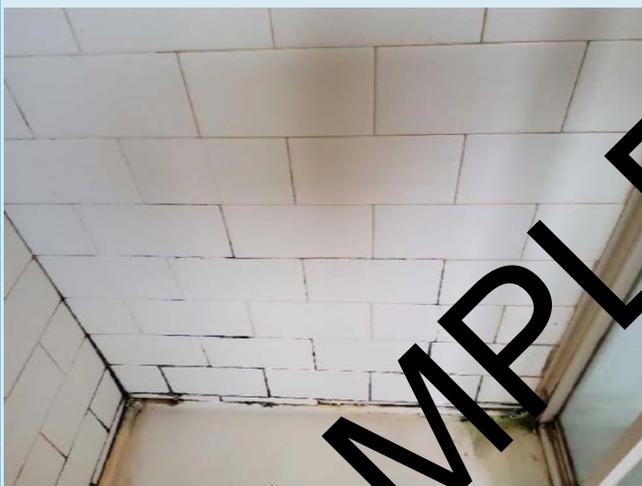
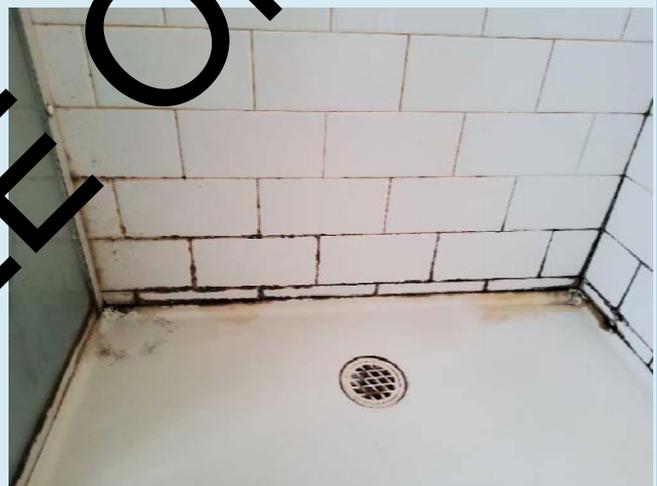
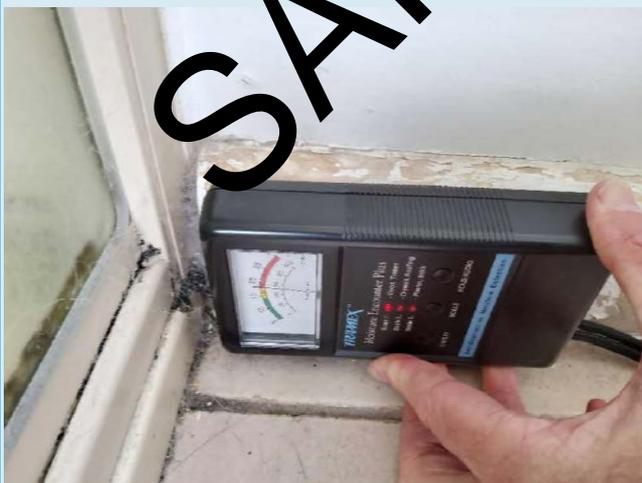
Upper level bathroom - Water stains and damage to skirting boards and wall lining in linen cupboard behind the shower, alongside the shower. Cracked tiles and damage lower tiles in the shower recess. Elevated moisture level when tested by moisture meter indicates current leak from the shower recess, probably due to failing waterproofing behind the tiles.

**The house presents in average condition overall for its age and type of construction. Upper level bathroom was leaking.**

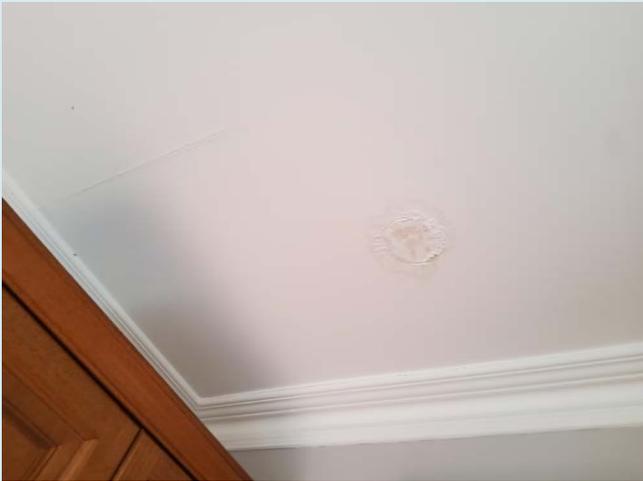
<b>Internal areas</b>	
<b>Damage advice on Item</b>	<b>Kitchen</b>
<b>Comments</b>	
Water damage noted to ceiling below the shower recess, was dry at the time of inspection when tested by moisture meter.
